**Chicken Ranch Beach Restoration Plan
Scoping Document**

Environmental Action Committee of West Marin

Philip Williams & Associates, Ltd.

April 2005

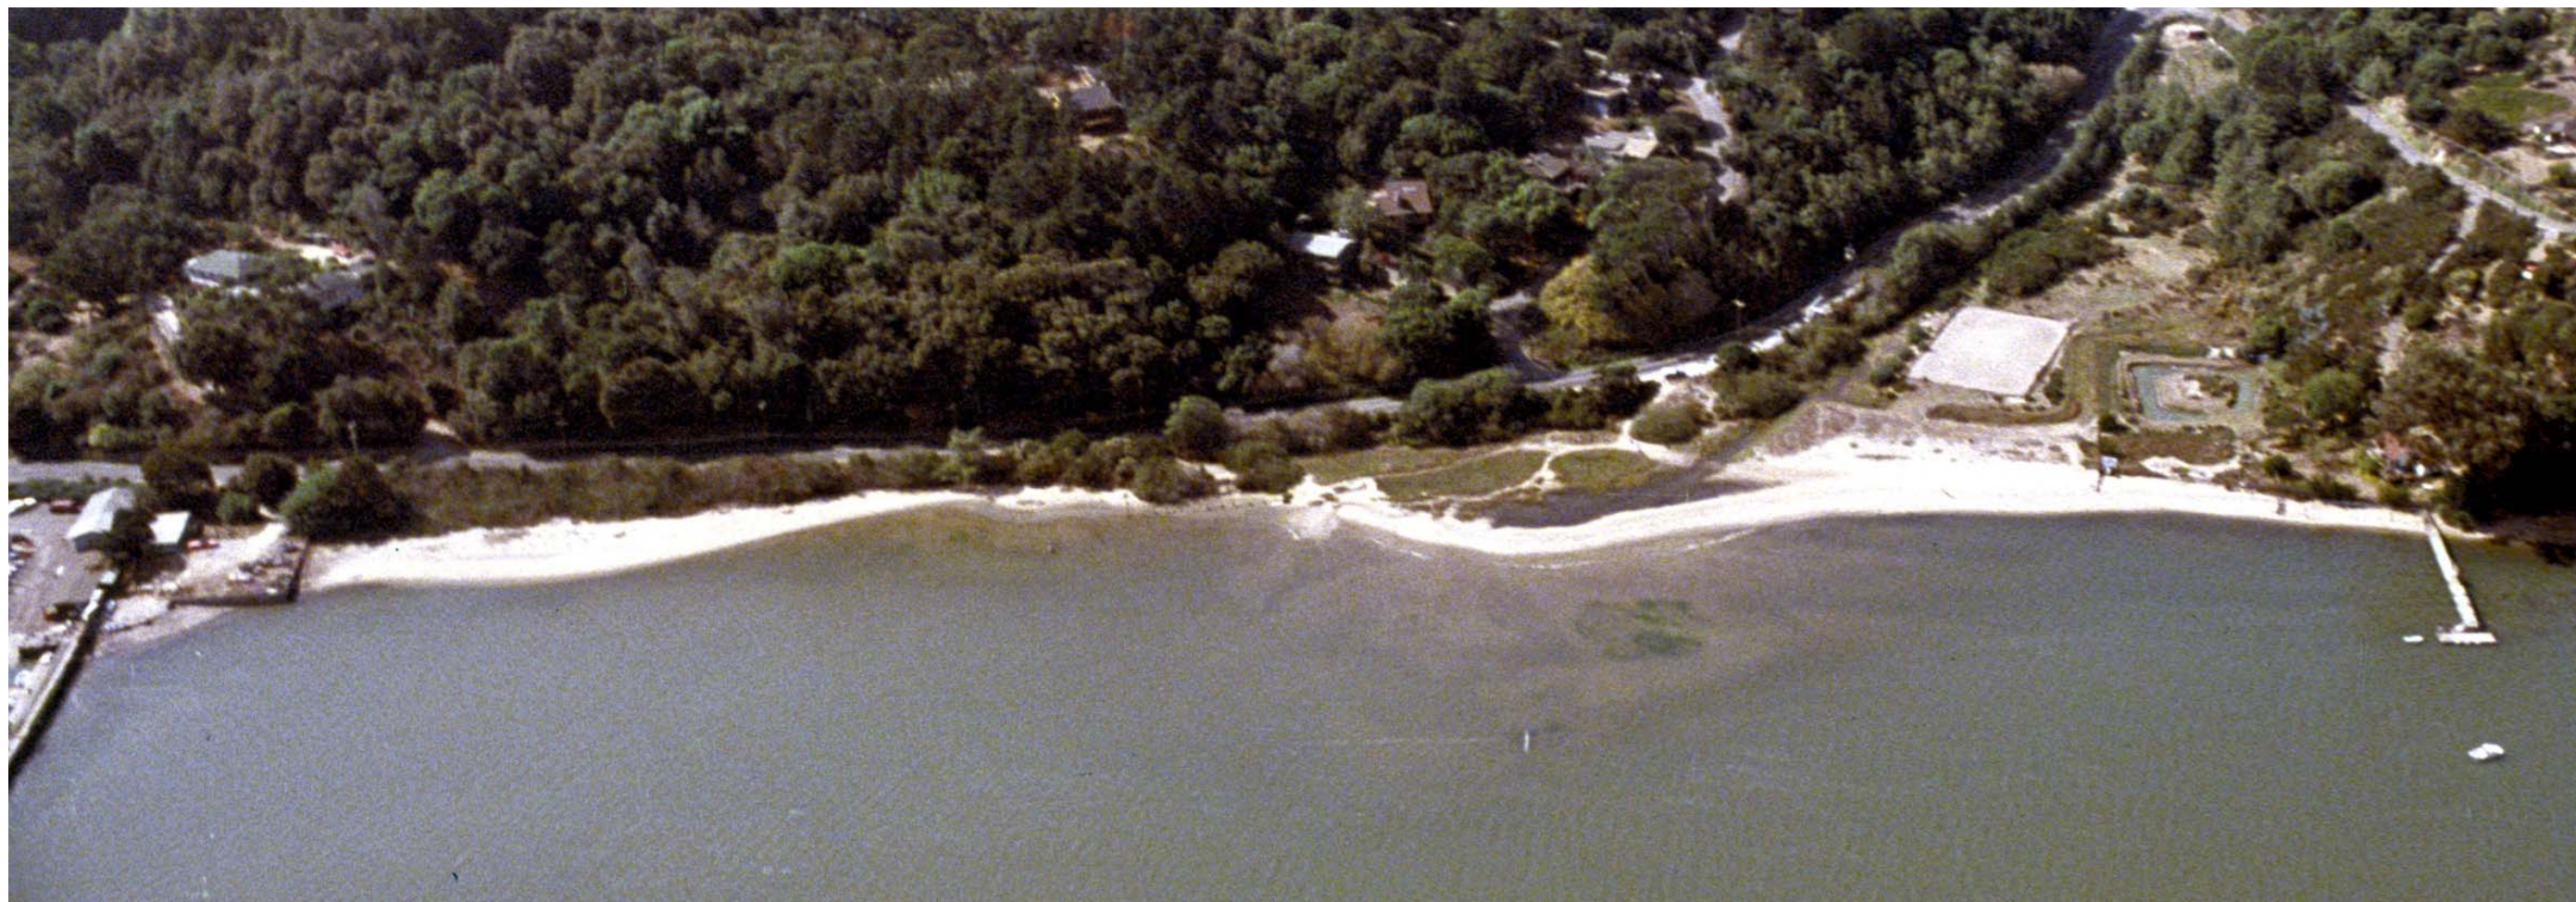
figure 1
Chicken Ranch Beach

Photograph taken October 10, 1979 at 12:25. Tidal elevation is about 2.8ft MLLW (2 hours after Low Water of 2.1ft MLLW)
Copyright © 2002-2004 Kenneth & Gabrielle Adelman, California Coastal Records Project, www.californiacoastline.org

The lagoon was connected to the Bay by a tidal channel behind the spit. The tidal prism of the lagoon (the volume of water flowing in and out of the lagoon on each tide) would have kept the channel open during dry periods. Deposition along the channel resulted in the establishment of wetlands behind the spit and between the abandoned recurves. This is the channel alignment shown in the October 1979 aerial photograph (Figure 1).

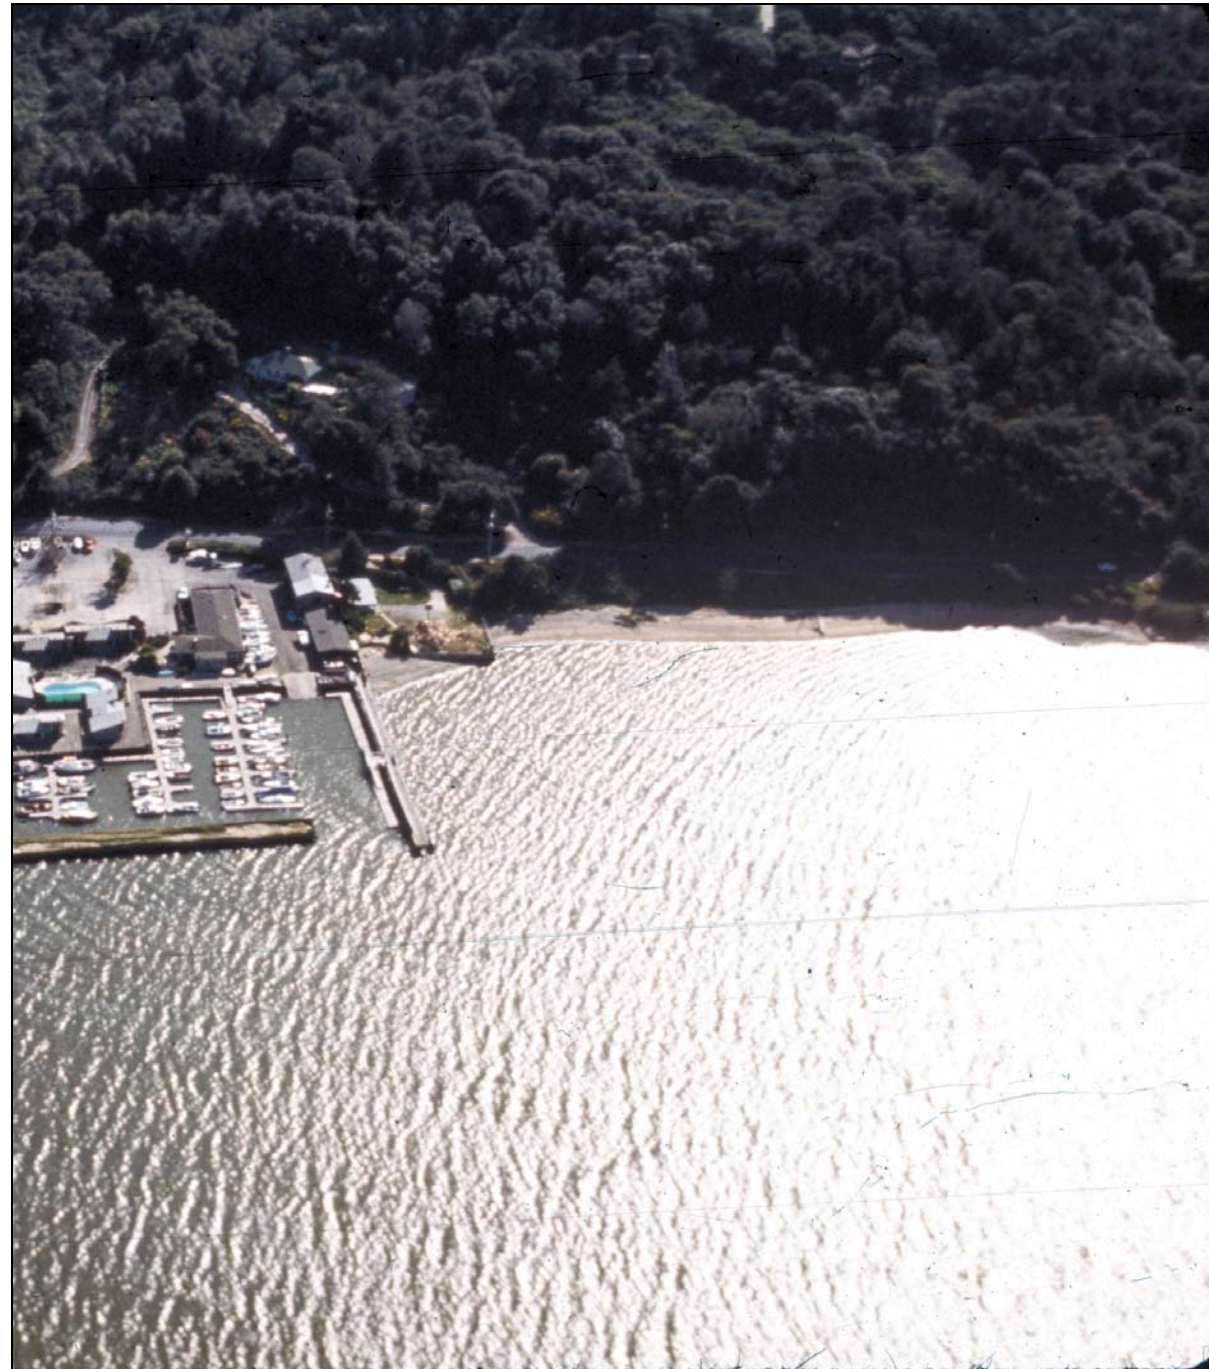
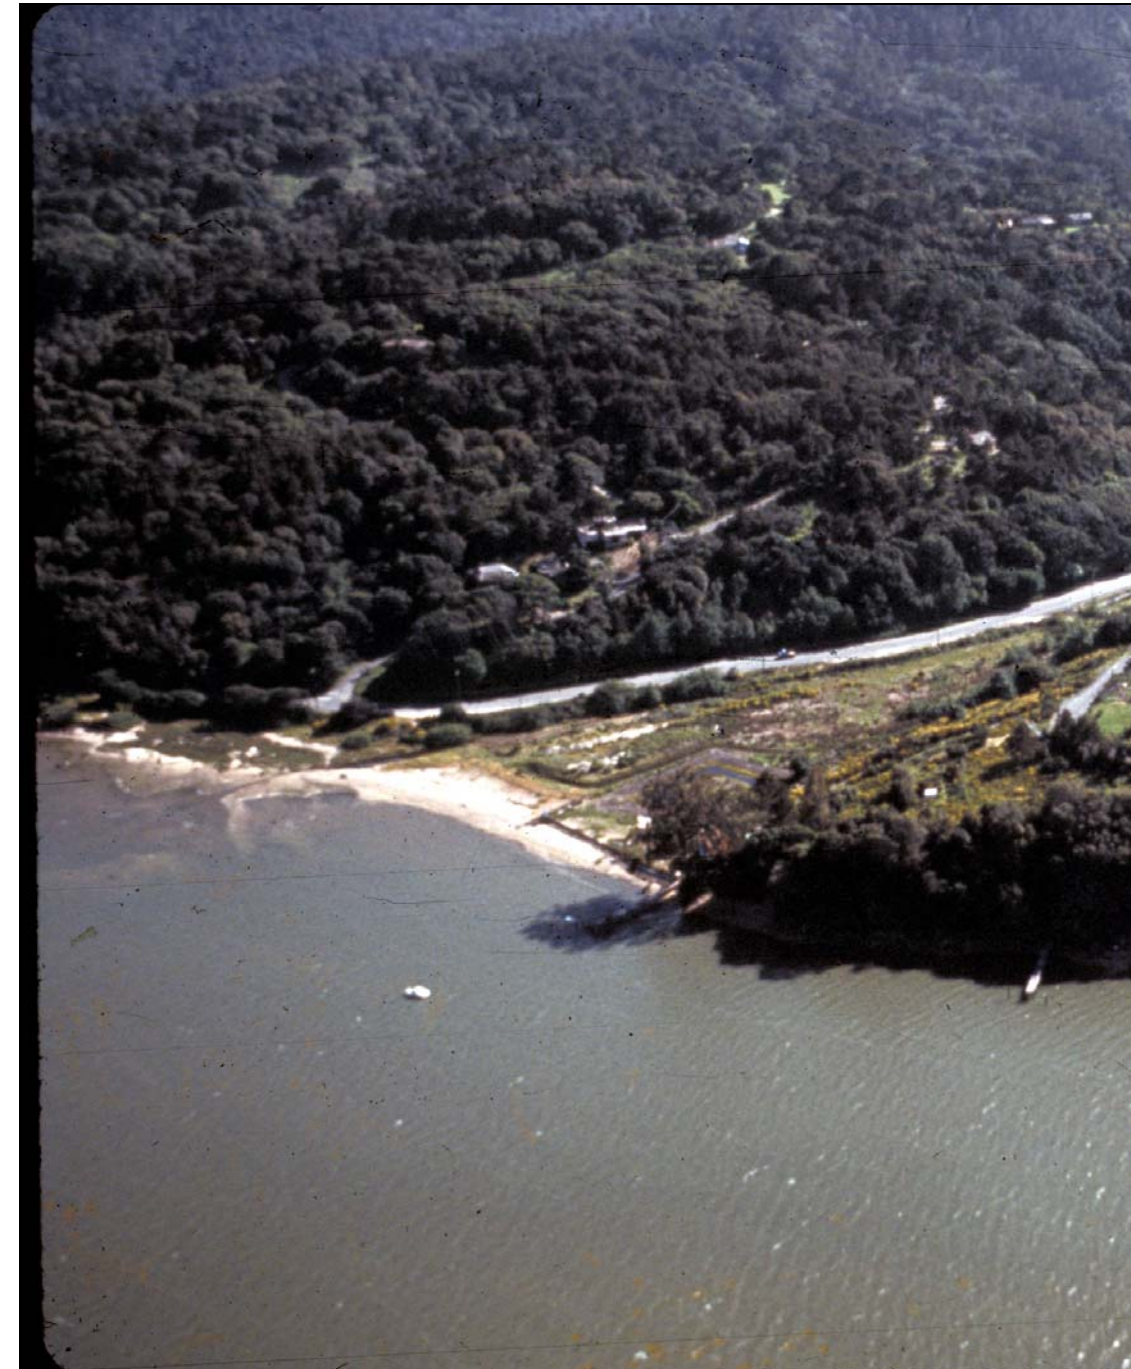
figure 2
Chicken Ranch Beach

Photograph taken in 1972.
Copyright © 2002-2004 Kenneth & Gabrielle Adelman, California Coastal Records Project, www.californiacoastline.org

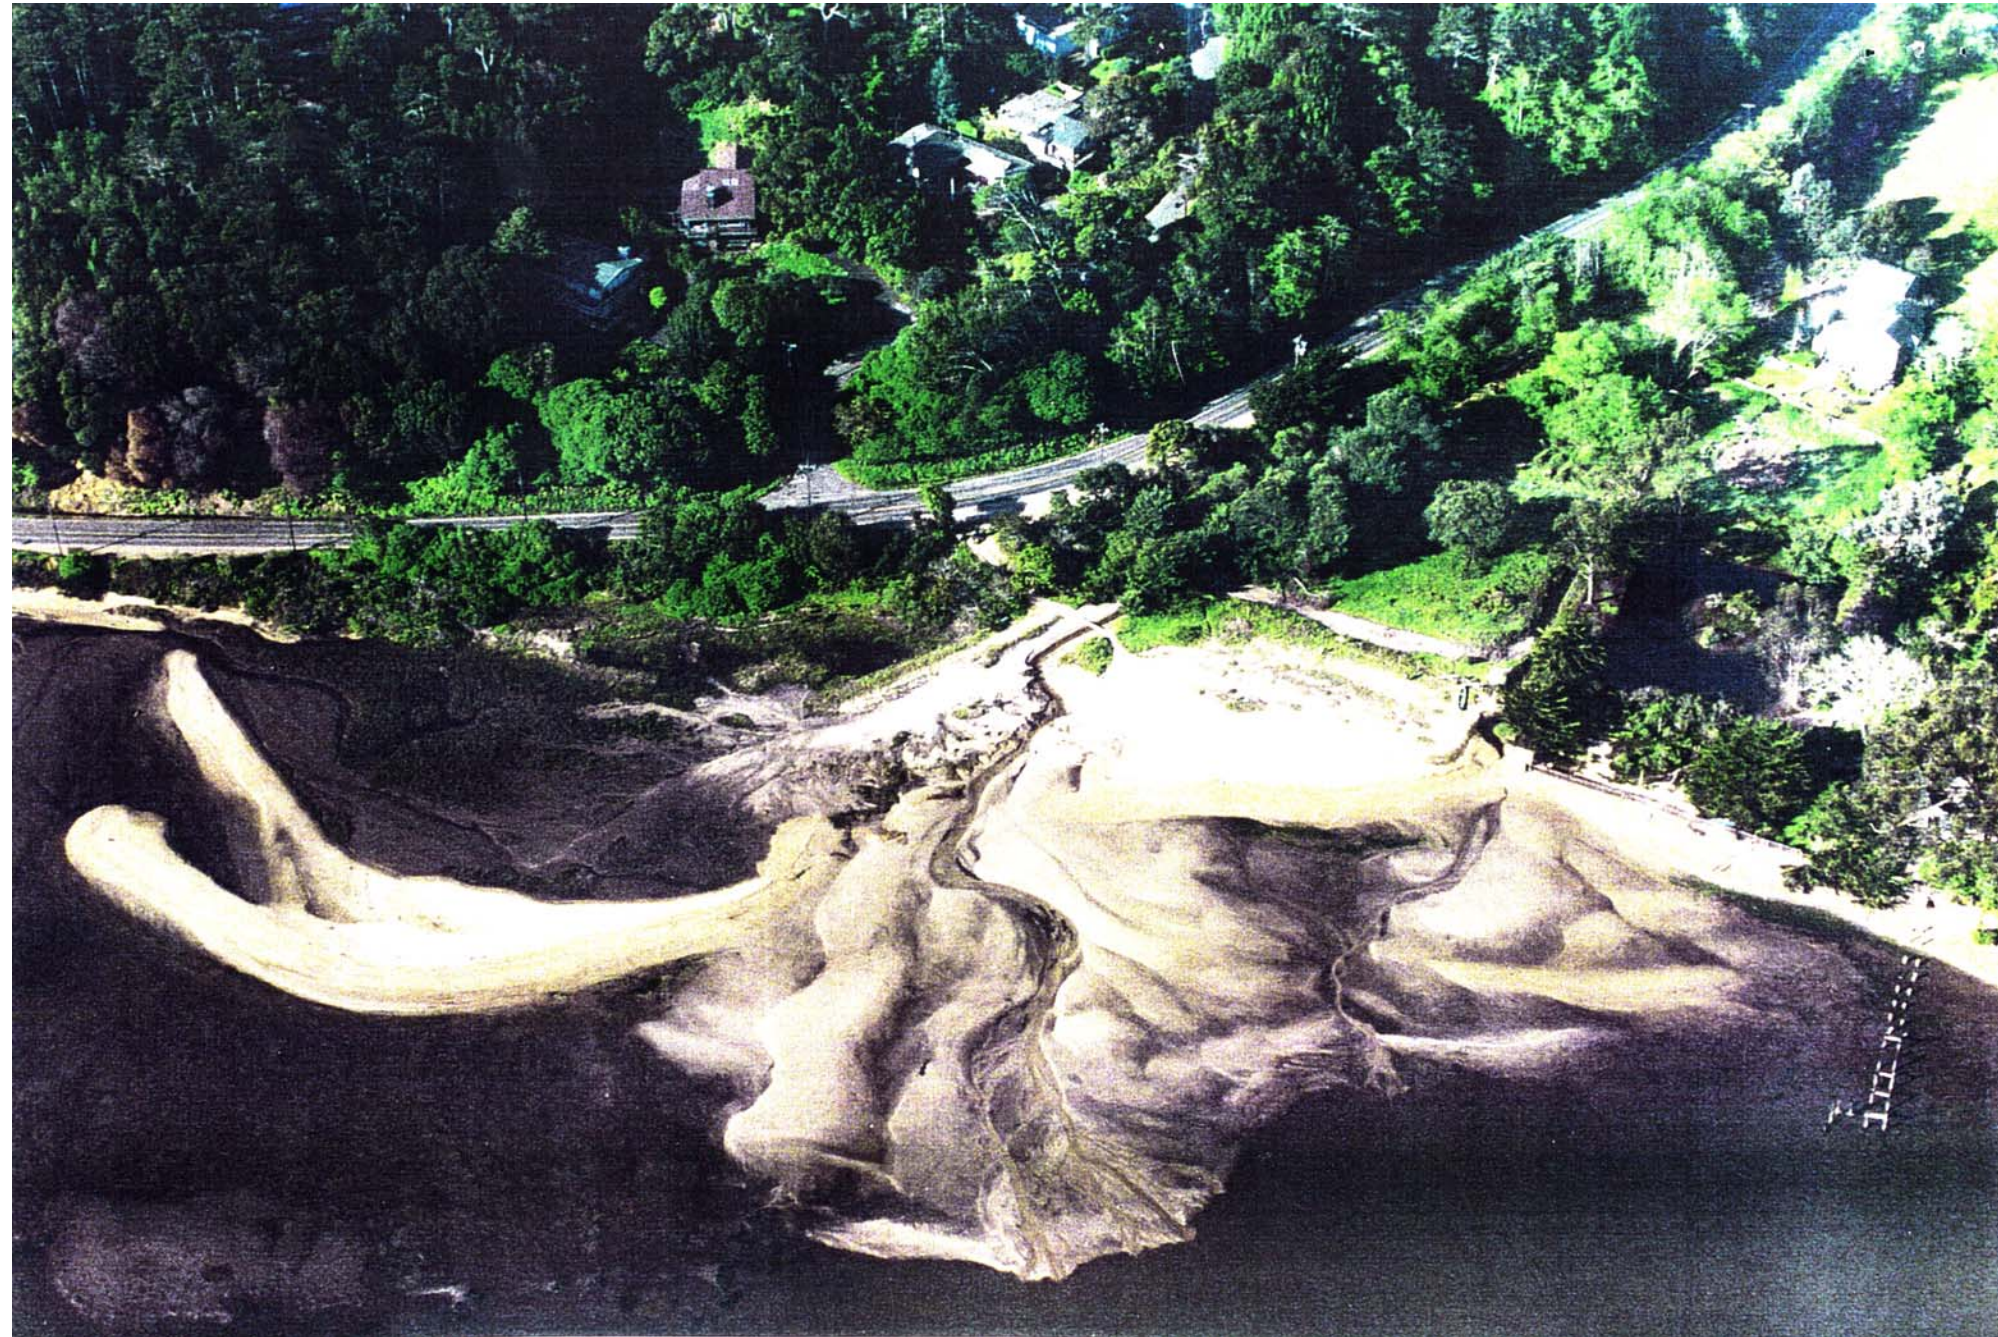
figure 3
Chicken Ranch Beach

Photograph taken March 30, 1998 at Low Water (-0.7ft MLLW)
Source: Krone (1999)

During periods of high creek discharges, backwater conditions occur upstream of the long hydraulically inefficient channel and the creek may flow over the low and narrow neck of the spit. The creek abandons the channel behind the spit and cuts a channel further north across the beach. The new channel is straighter and takes a more direct and hydraulically efficient route to the bay. The short channel can be seen in the aerial photographs of 1972, March 1998 and November 2002 (Figure 2, Figure 3 and Figure 4 respectively). Large volumes of water and sediment are discharged into the bay during these flood events. As the channel reaches the bay the flow velocity decreases and the coarser sediment is deposited as a delta; the finer sediment is carried farther into the bay where they are distributed by tidal currents. The delta can be clearly seen in the aerial photographs of March 1998 and November 2002 (Figure 3 and Figure 4).

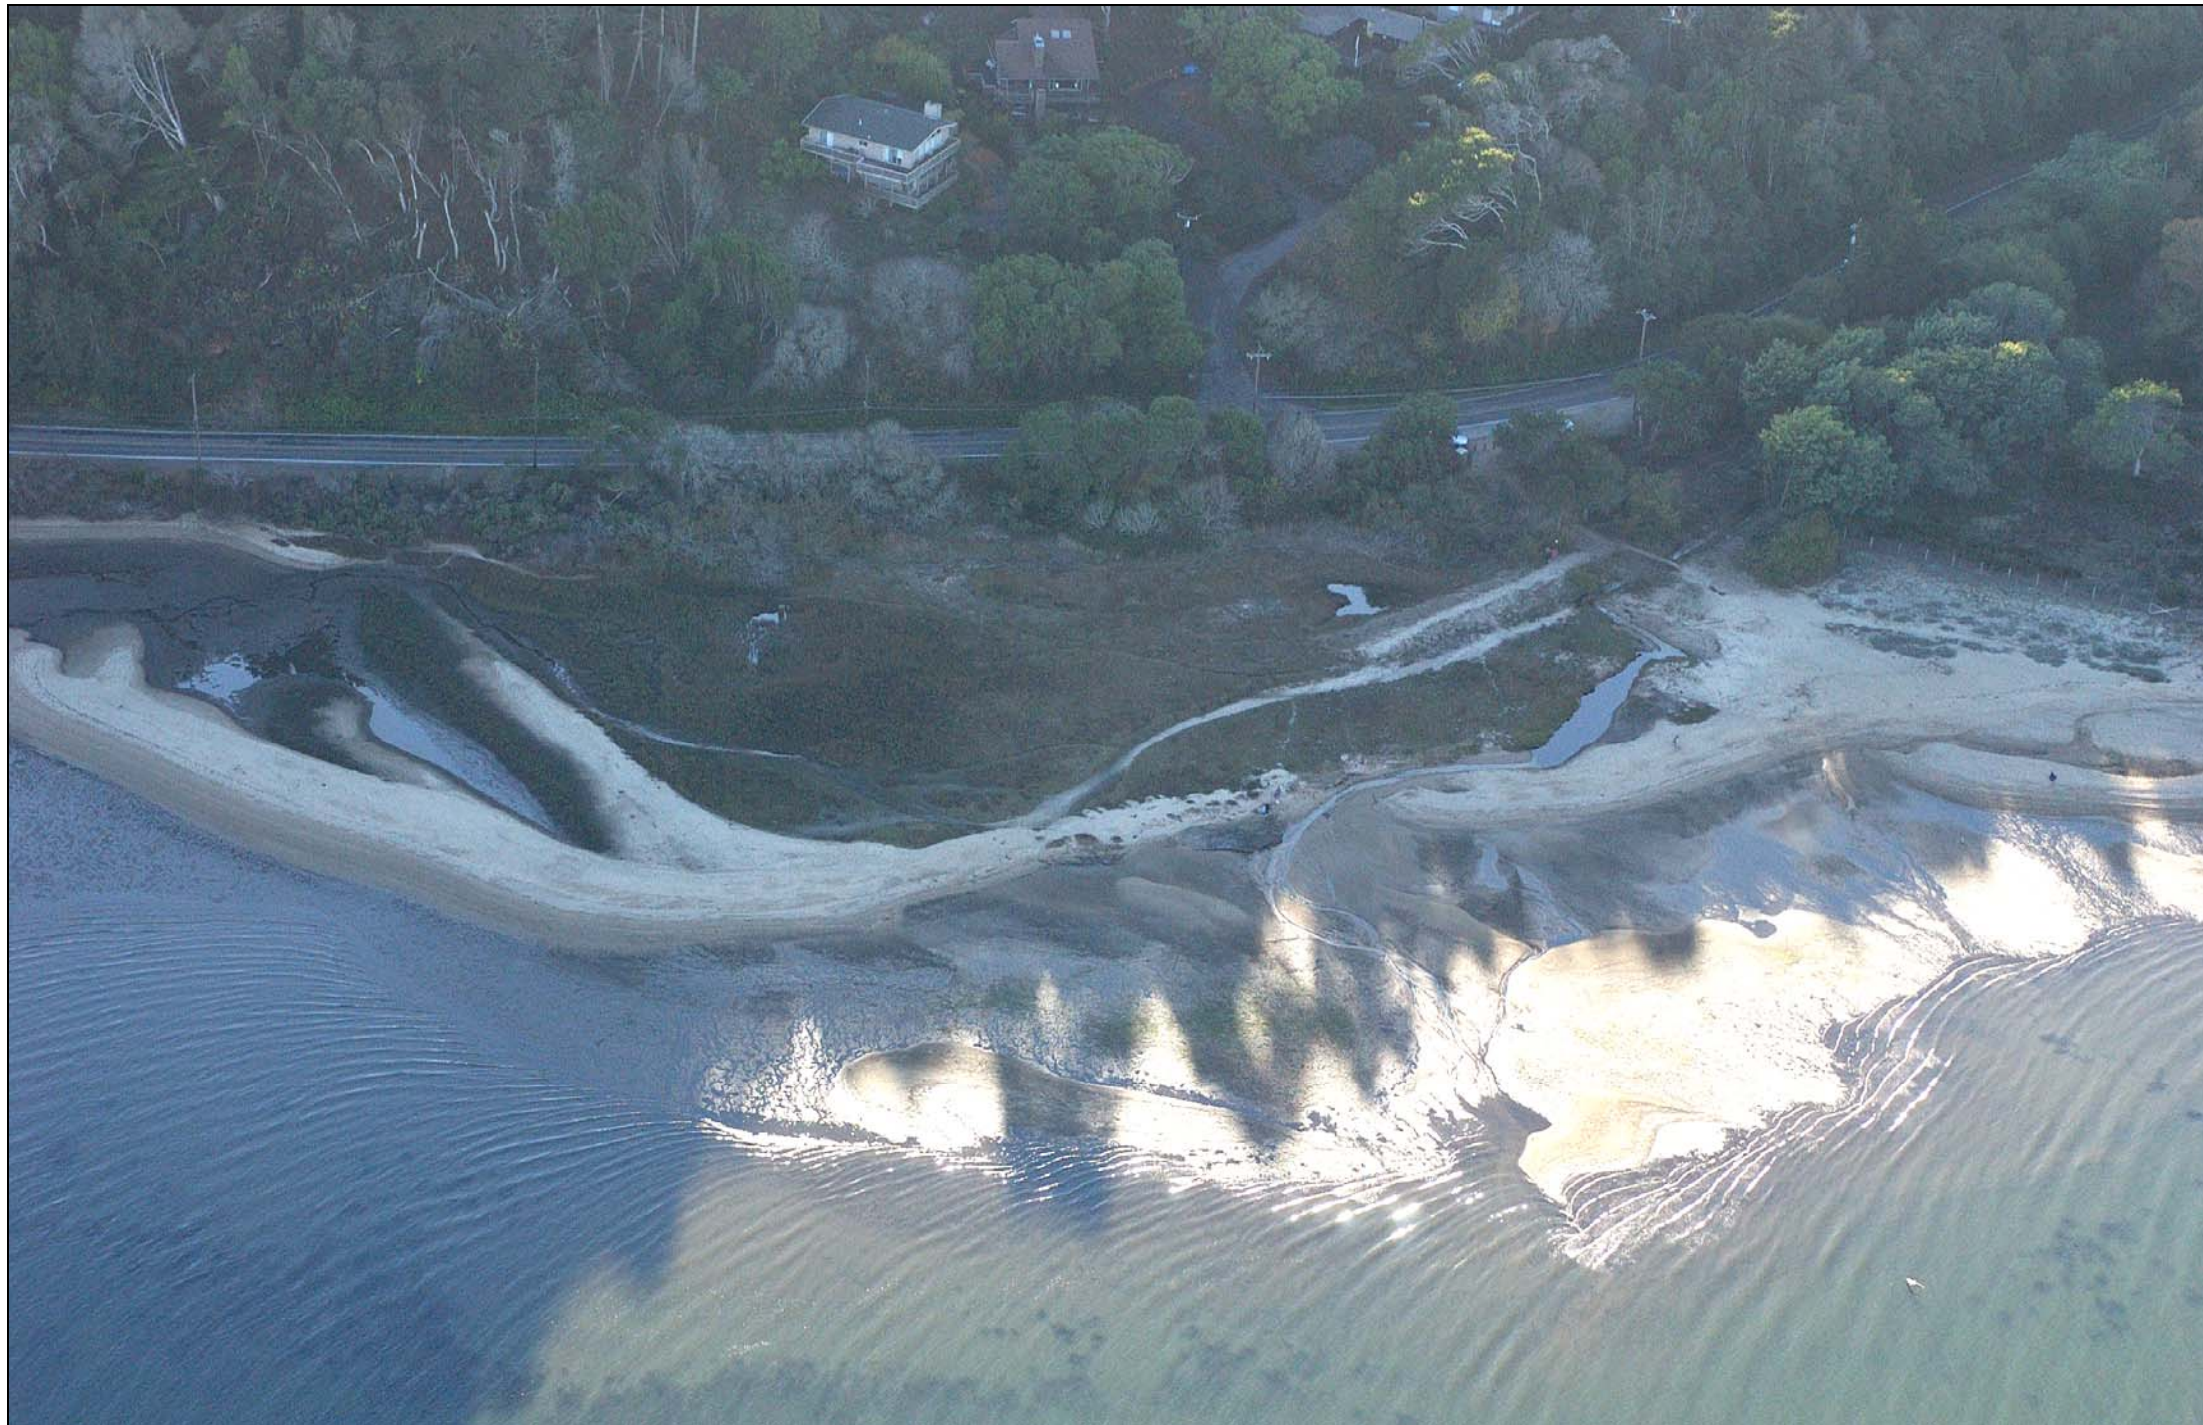
figure 4a
Chicken Ranch Beach

Photograph taken November 14, 2002 at 14:39. Tidal elevation approximately 1.6 ft MLLW (1 hour before Low Water of 1.5ft MLLW)
Copyright © 2002-2004 Kenneth & Gabrielle Adelman, California Coastal Records Project, www.californiacoastline.org

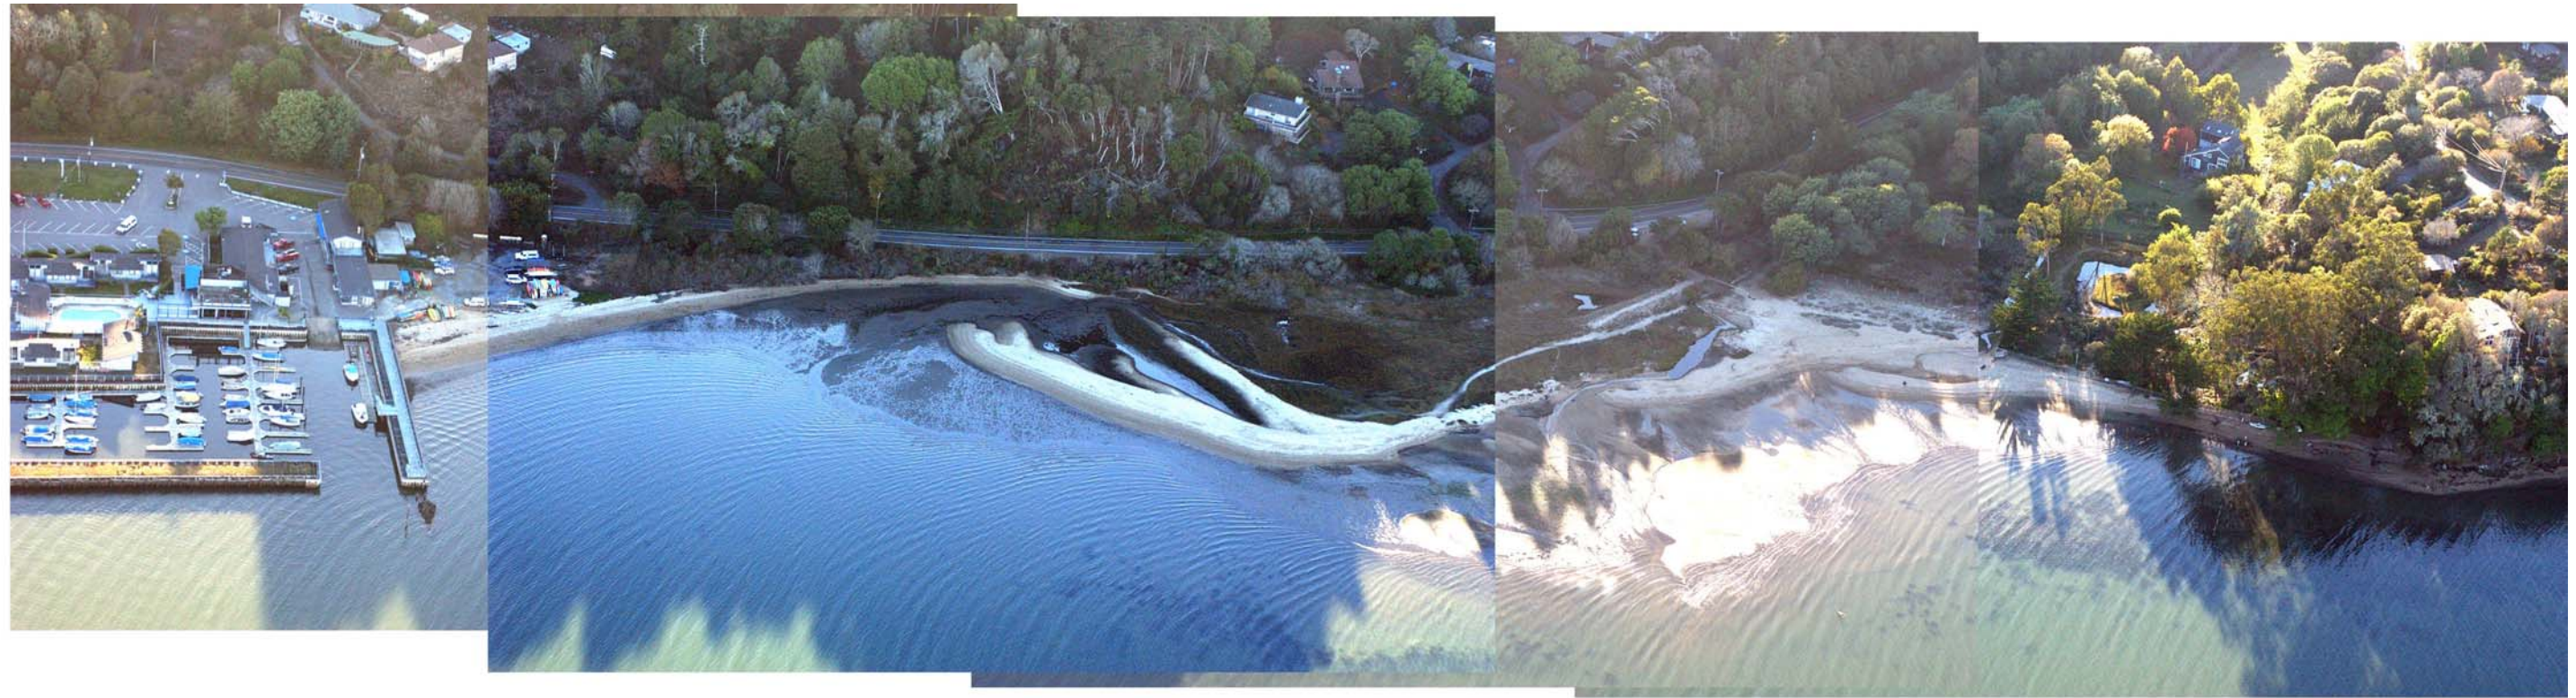
figure 4b
Chicken Ranch Beach

Photograph taken November 14, 2002 at 14:39. Tidal elevation approximately 1.6 ft MLLW (1 hour before Low Water of 1.5ft MLLW)
Copyright © 2002-2004 Kenneth & Gabrielle Adelman, California Coastal Records Project, www.californiacoastline.org
